WAYNESVILLE
FACILITY NUMBER 0390300
WELL SITE SURVEY
REPORT

IEPA/PWS/91-75

April 1991

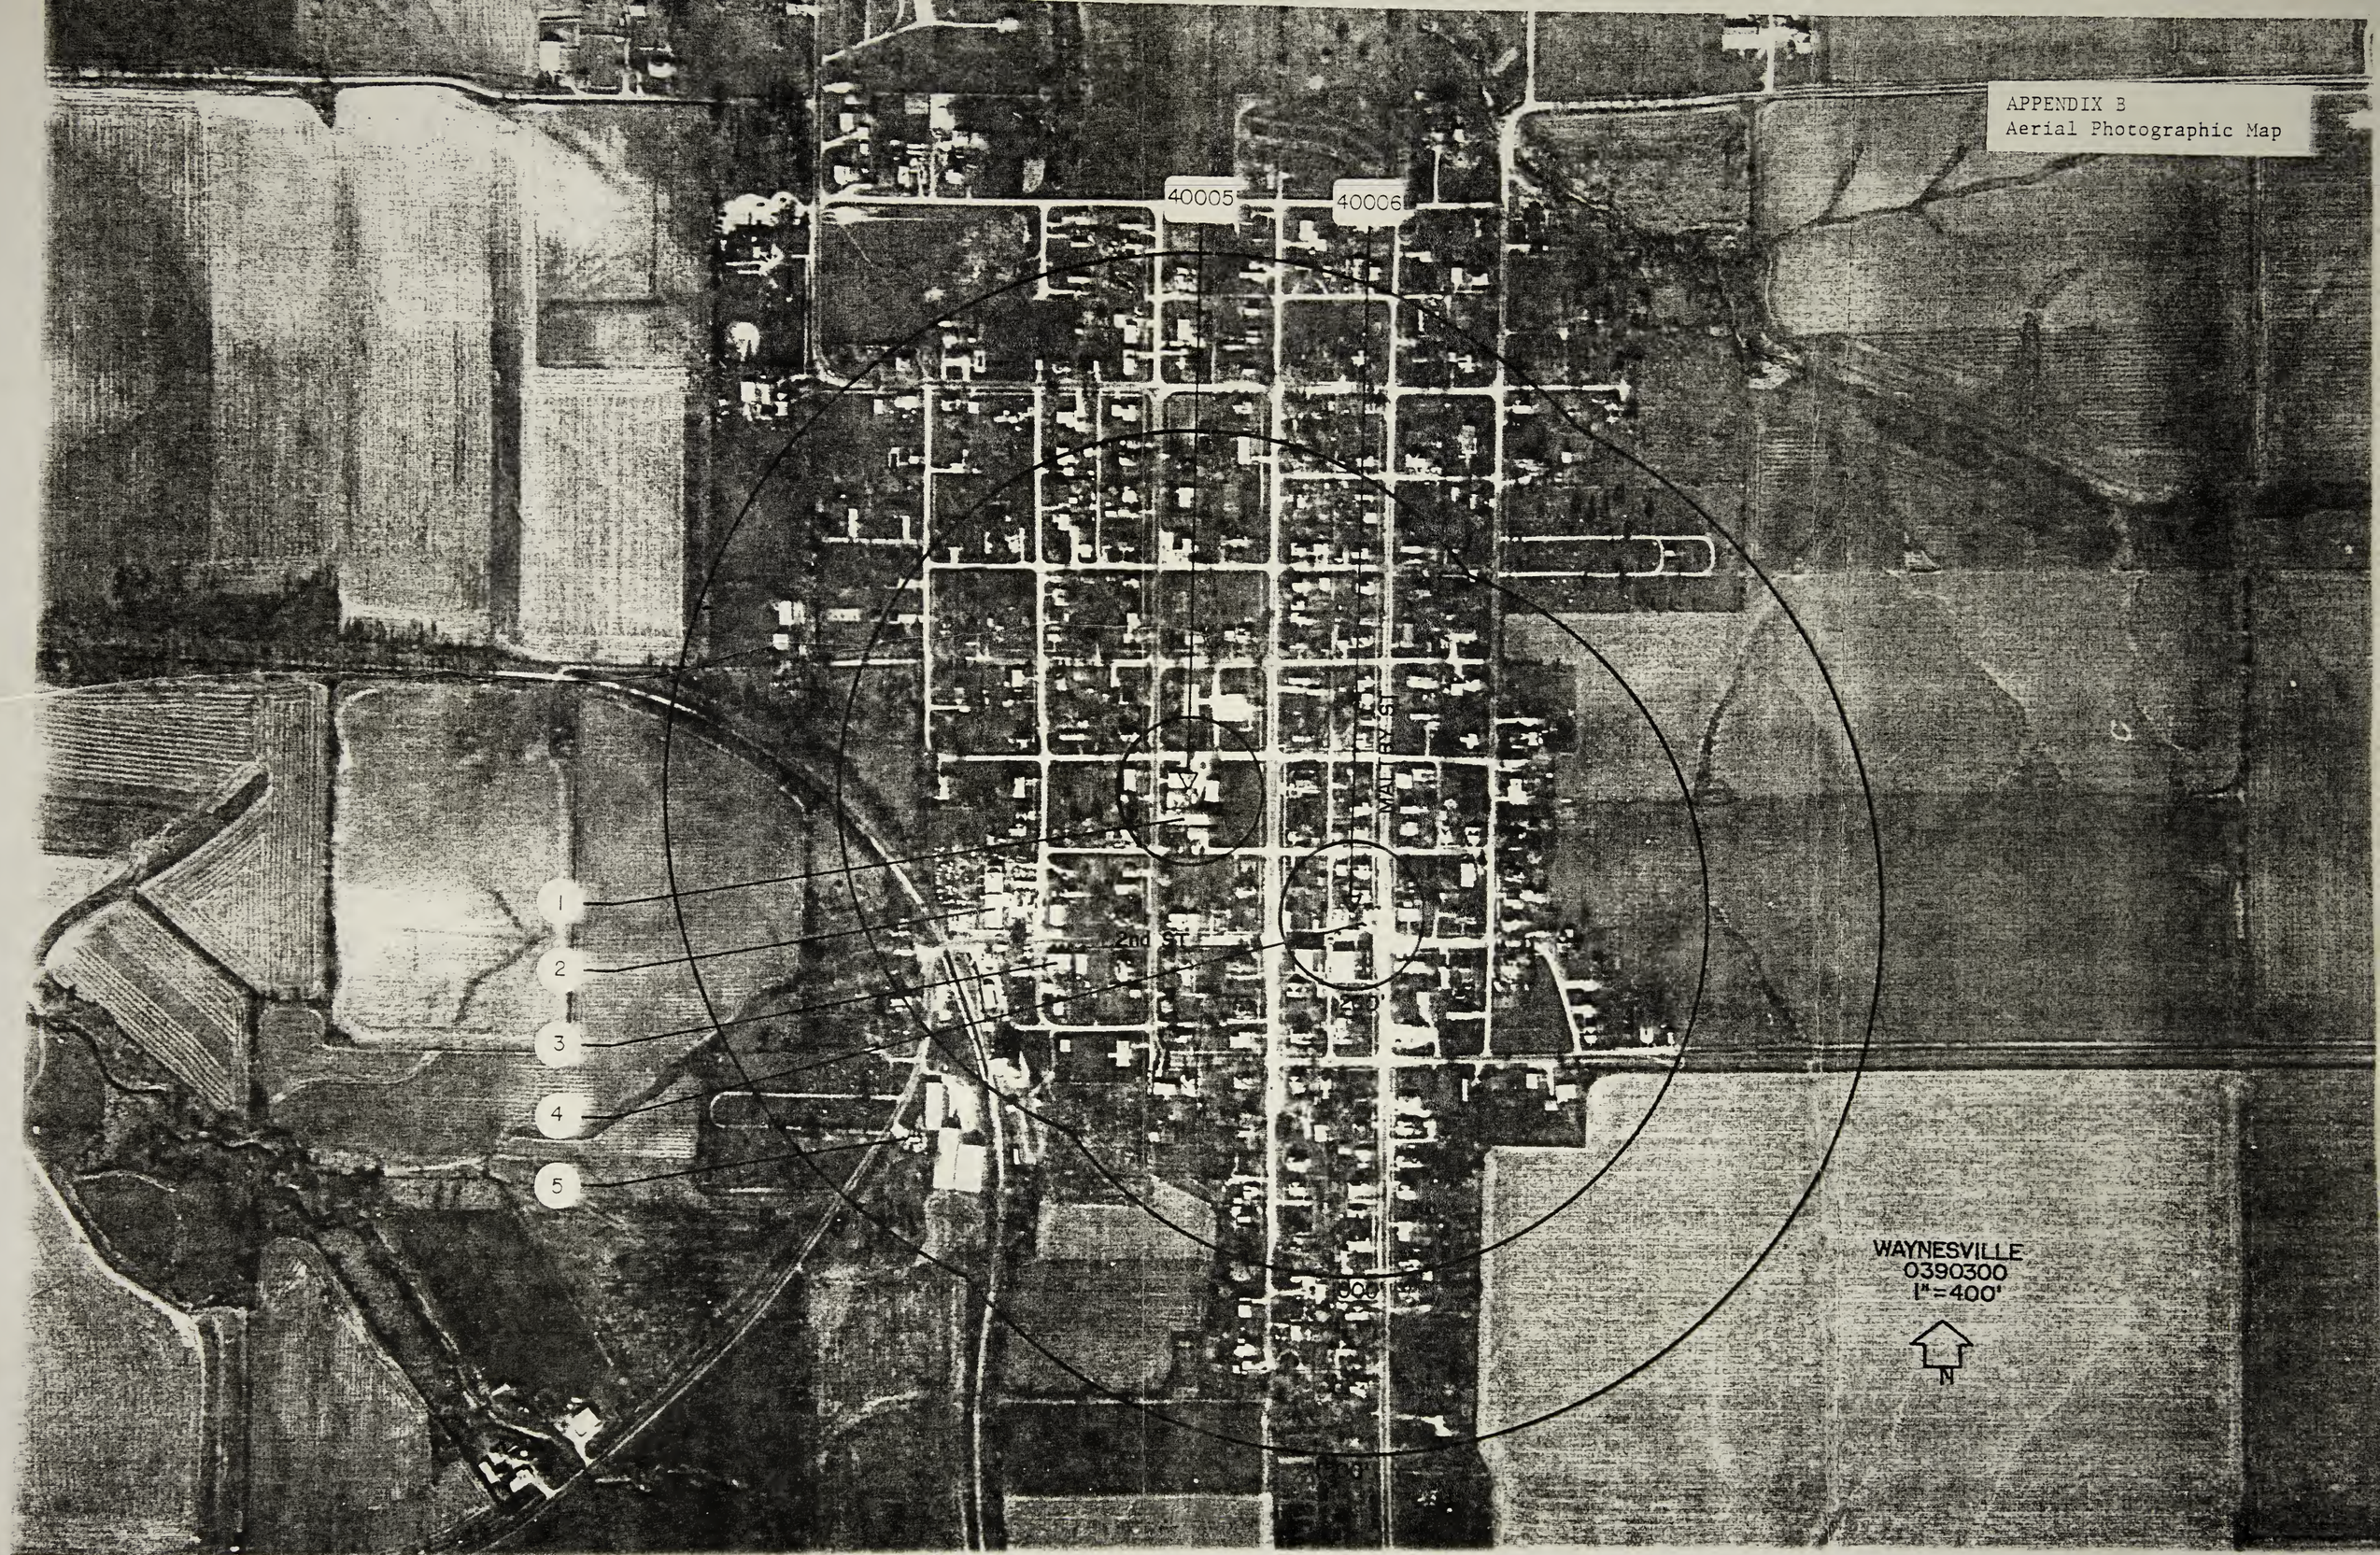
APPENDIX B
Aerial Photographic Map

The survey area is mostly rural. The area is a mixture of residential, row crops and commercial. There are five possible problem sites within 1,500 feet of well #8. They are the village garage (map code 1) 50 ft S, farm implement sales (map code 2) 500 ft SW, White's Autobody (map code 3) 580 ft SW, Furmans Sunoco (map code 4) 650 ft SE and bulk fuel storage (map code 5) 1,250 ft SW.

The survey area is mostly rural. The area is a mixture of residential, row crops and commercial. There is one potential secondary source and four possible problem sites located within 1,500 feet of well #6. The potential secondary source is Furmans Sunoco (map code 4) 50 ft SE. The possible problem sites are the village garage (map code 1) 600 ft NW, farm implement sales (map code 2) 1,000 ft W, White's Autobody (map code 3) 850 ft WSW and bulk fuel storage (map code 5) 1,400 ft SW.

WELL NO. - MAP CODE - CLASSF*: 40005-01
NAME & ADDRESS OF UNIT OWNER: Village of Waynesville, Village Hall, Waynesville, IL 61778
DESCRIPTION AND COMMENTS: village garage, small above ground fuel tank
PRE OR POST (Y,N): Y
DISTANCE AND DIRECTION: 50 ft S

WELL NO. - MAP CODE - CLASSF*: 40005-02
NAME & ADDRESS OF UNIT OWNER: unknown, W 2nd St, Waynesville, IL 61778
DESCRIPTION AND COMMENTS: farm implement sales
PRE OR POST (Y,N): Y
DISTANCE AND DIRECTION: 500 ft SW

WELL NO. - MAP CODE - CLASSF*: 40005-03
NAME & ADDRESS OF UNIT OWNER: White's Autobody, W 2nd St, Waynesville, IL 61778
DESCRIPTION AND COMMENTS: auto repair shop
PRE OR POST (Y,N): Y
DISTANCE AND DIRECTION: 580 ft SW

WELL NO. - MAP CODE - CLASSF*: 40005-04-OS
NAME & ADDRESS OF UNIT OWNER: Furmans Sunoco, 2nd and Maltby, Waynesville, IL 61778 217/949-2511
DESCRIPTION AND COMMENTS: service station w/below ground fuel storage in excess of 500 gallons, ISFM #4-009645
PRE OR POST (Y,N): Y
DISTANCE AND DIRECTION: 650 ft SE

WELL NO. - MAP CODE - CLASSF*: 40005-05-
NAME & ADDRESS OF UNIT OWNER: unknown, Waynesville, IL 61778
DESCRIPTION AND COMMENTS: above ground bulk fuel storage
PRE OR POST (Y,N): Y
DISTANCE AND DIRECTION: 1250 ft SW

WELL NO. - MAP CODE - CLASSF*: 40006-01
NAME & ADDRESS OF UNIT OWNER: Village of Waynesville, Village Hall, Waynesville, IL 61778
DESCRIPTION AND COMMENTS: village garage, small above ground fuel tank
PRE OR POST (Y,N): Y
DISTANCE AND DIRECTION: 600 ft NW

WELL NO. - MAP CODE - CLASSF*: 40006-02
NAME & ADDRESS OF UNIT OWNER: unknown, W 2nd St, Waynesville, IL 61778
DESCRIPTION AND COMMENTS: farm implement sales
PRE OR POST (Y,N): Y
DISTANCE AND DIRECTION: 1000 ft W

WELL NO. - MAP CODE - CLASSF*: 40006-03
NAME & ADDRESS OF UNIT OWNER: White's Autobody, W 2nd St, Waynesville, IL 61778
DESCRIPTION AND COMMENTS: auto repair shop
PRE OR POST (Y,N): Y
DISTANCE AND DIRECTION: 850 ft WSW

WELL NO. - MAP CODE - CLASSF*: 40006-04-OS
NAME & ADDRESS OF UNIT OWNER: Furmans Sunoco, 2nd and Maltby, Waynesville, IL 61778 217/949-2511
DESCRIPTION AND COMMENTS: service station w/below ground fuel storage in excess of 500 gallons, ISFM #4-009645
PRE OR POST (Y,N): Y
DISTANCE AND DIRECTION: 50 ft SE

WELL NO. - MAP CODE - CLASSF*: 40006-05-
NAME & ADDRESS OF UNIT OWNER: unknown, Waynesville, IL 61778
DESCRIPTION AND COMMENTS: above ground bulk fuel storage
PRE OR POST (Y,N): Y
DISTANCE AND DIRECTION: 1400 ft SW
